# Introducing the MEI Patented Closed Guide Pin System

# The Solution

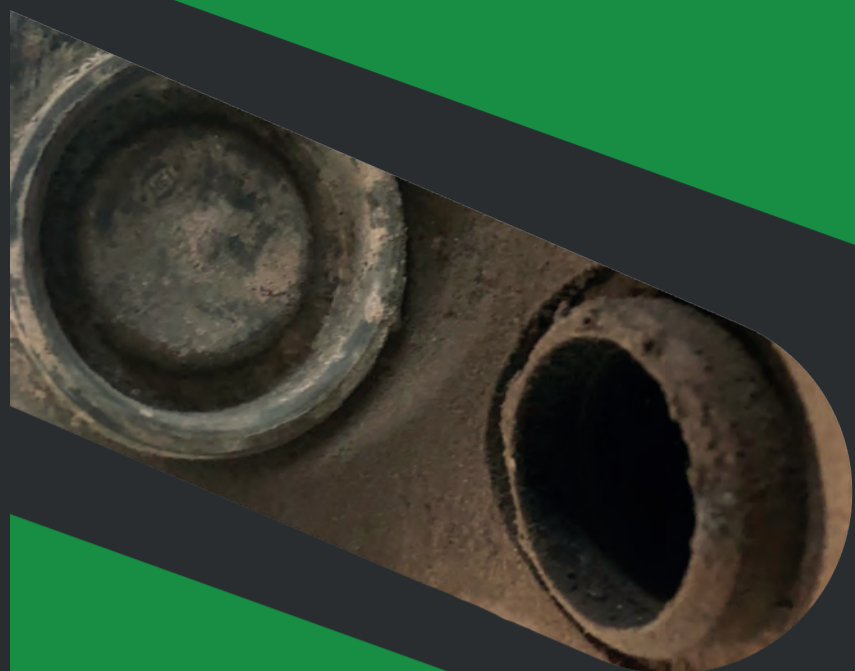
Water and dirt ingress has long been an issue for brake calipers causing sliding problems on many applications. Symptoms include:

- Hot Brakes, Excessive Outboard Pad Wear & Brake Rotor Wear, Leading to:
- Fleet Downtime, Higher Lifetime Caliper Costs & Increased Fleet Costs

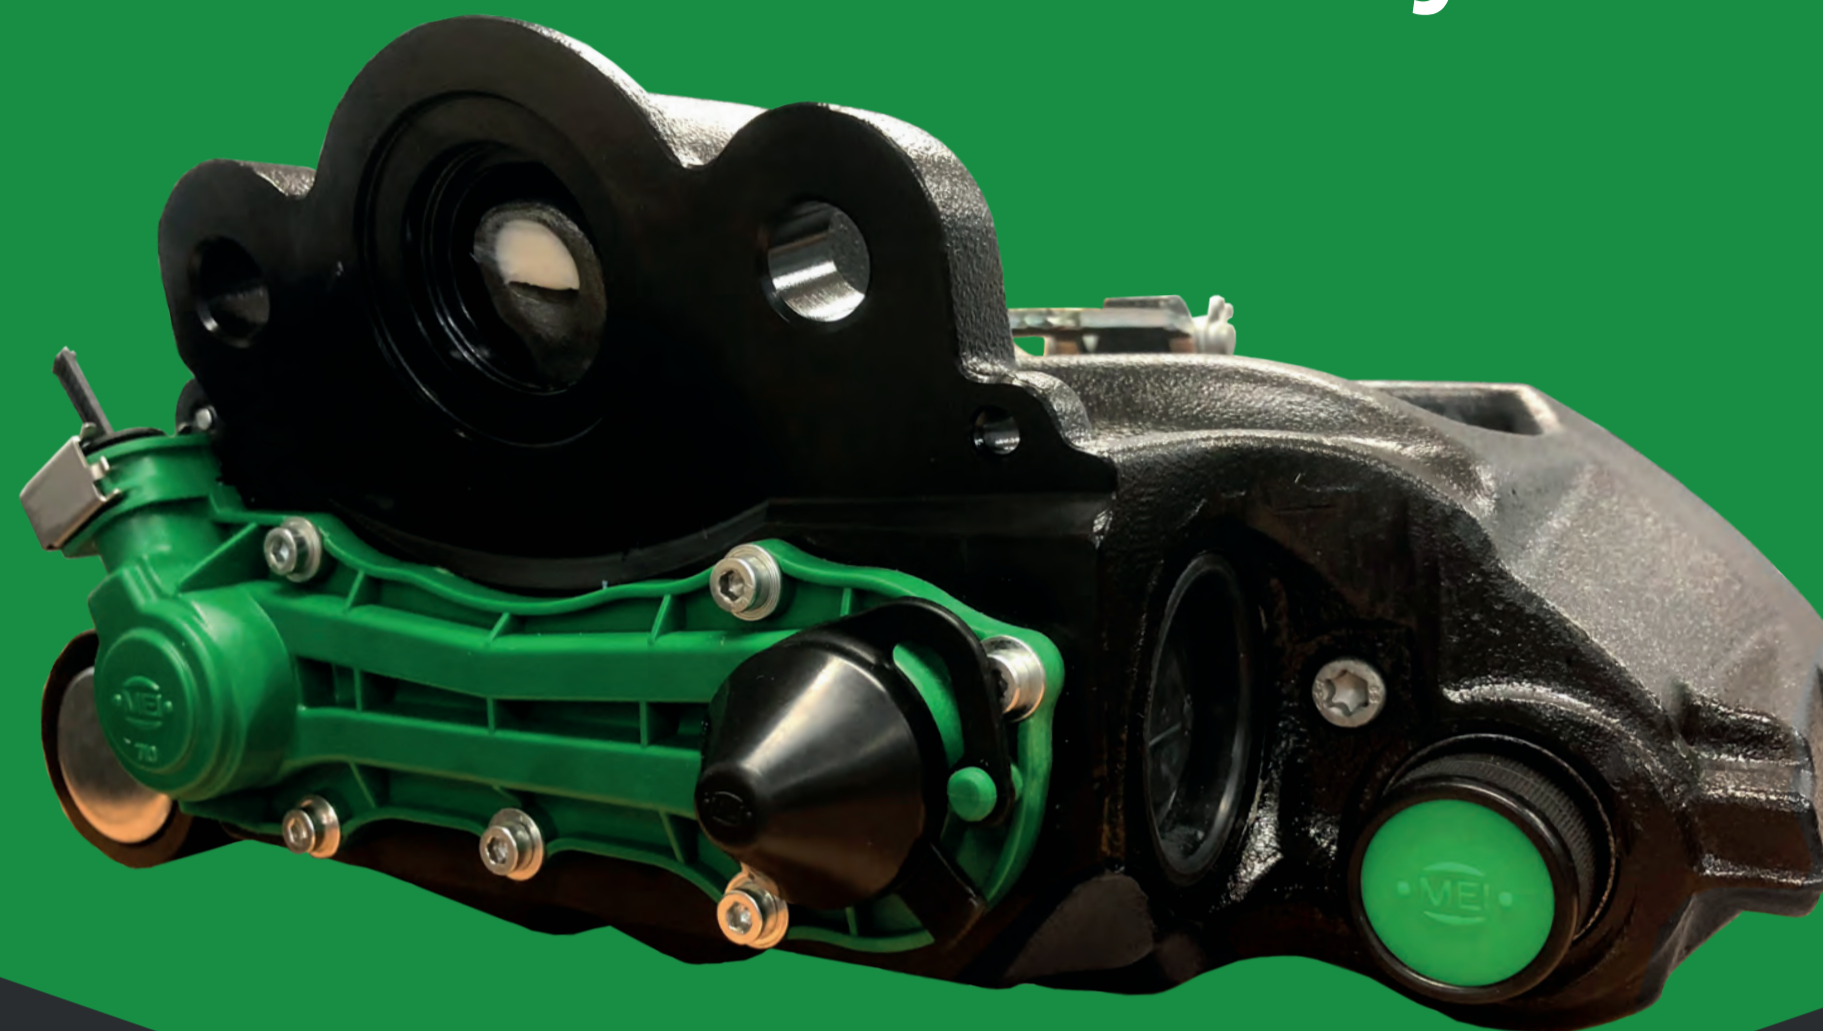
- Tested in the Field
- MEI Patented System
- MEI Click & Seal Boot Cap
- Fully Sealed Short Guide Pin
- Unique Design for MEI Calipers
- Sealed Boot to Protect the Exposed Guide Pin
- Stainless Steel Outer Sleeve on the Rubber Bush

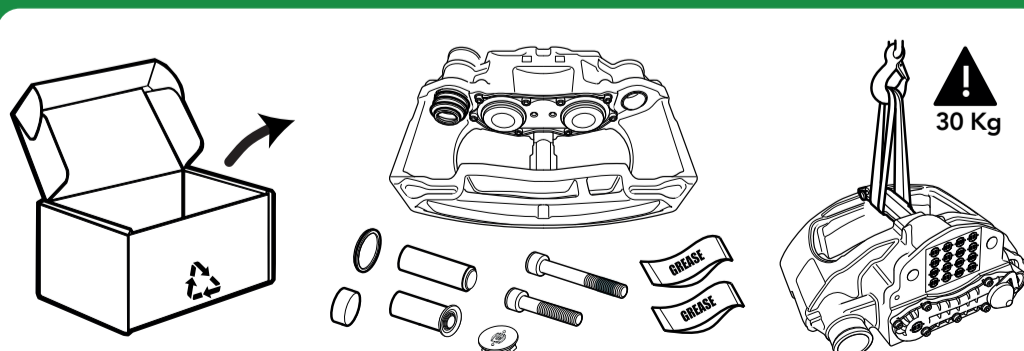
1. Remove the new caliper and guide sleeve kit from the packaging – use suitable lifting equipment for the caliper. Check that the new parts correspond with those that have been removed.

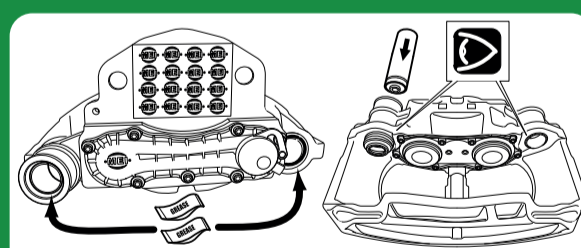
2. Grease both guide sleeves bores using the grease sachets provided. Slide the long guide sleeve in to the brass bush in the direction indicated.

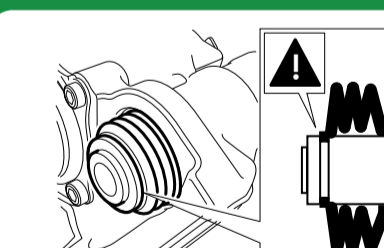
3. Locate the boot into the sealing groove in the guide sleeve ensuring it seals correctly around the sleeve. A little grease will help the boot slip into the groove.

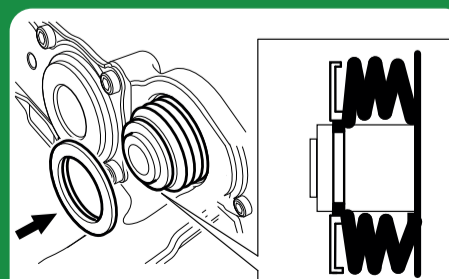
4. Locate the plastic washer over the boot to retain it in the sealing groove in the guide sleeve ensuring the washer is in the correct orientation.

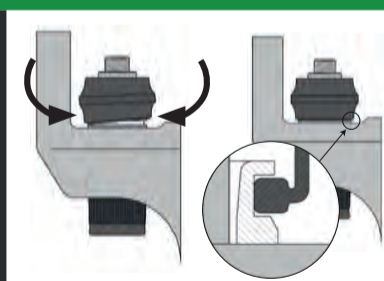
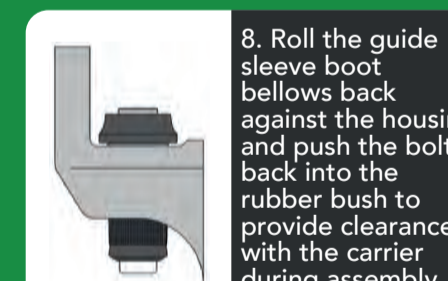
7. Locate the boot into the sealing groove in the housing retainer ensuring it seals correctly all around the groove.

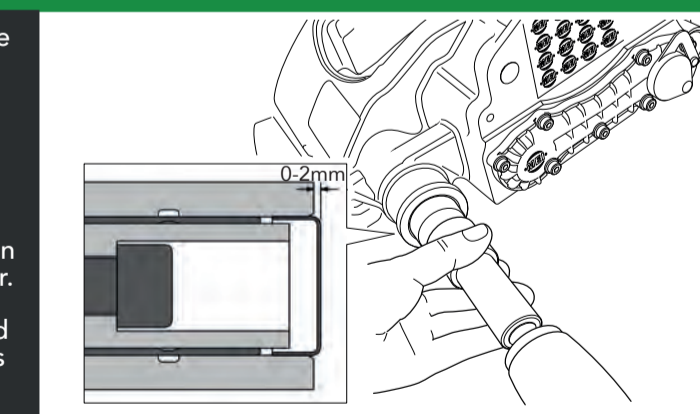
10. Locate the protective cap for the long guide sleeve into the caliper bore. Press the metal protective cap into the long guide sleeve bore. Fitting the protective caps can only be done after the caliper has been fully bolted to the carrier. The guide sleeve boots must be in a compressed condition or the caliper's freedom of movement will be limited.

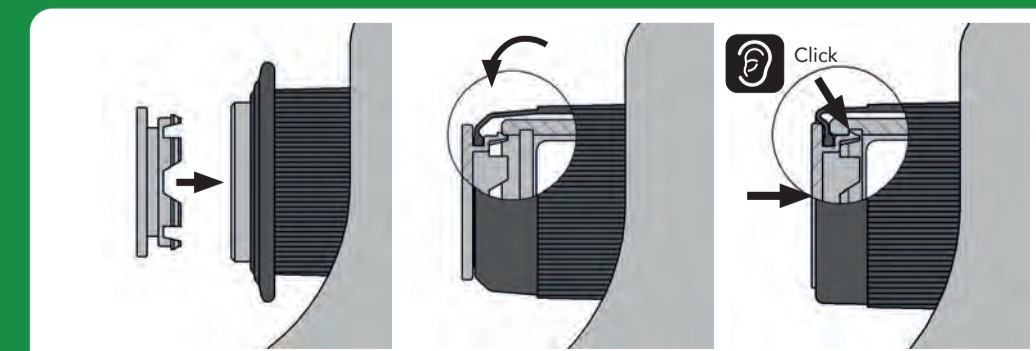
11. Stretch the rubber bush bellows over the short guide sleeve. Position the plastic cap in the end of the guide sleeve bore. Slide the bellows back over the plastic cap and then push the cap firmly into the guide sleeve so that it clicks into place.
